St. Thomas Square Villas
8730 Thomas Drive
Panama City Beach, FL 32408

Regarding: St. Thomas Square Villas – Phase I Milestone Inspection

**St. Thomas Square Villas
Appendix B – Photo Log
Site Visit Date: 03/15/23**

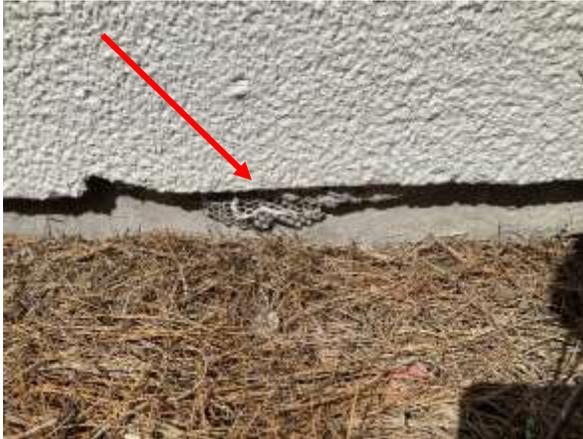
Photo 1
Base Of Wall – Ground level – Overall view of Stucco accessories at foundation.

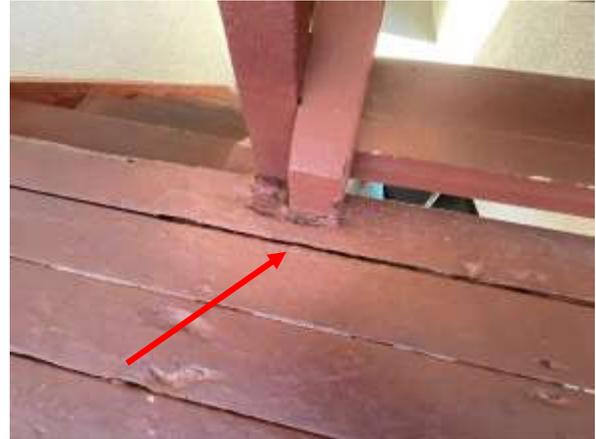
- 3.2.1 BE-CI observed deteriorated and detached deck boards to be typical at all stairwells at all buildings. This causes a safety hazard for pedestrians using the stairs to access the second level. BE-CI also observed that the existing deck joists at the stairwells had been toenailed and that no joist hangers had been installed, not in conformance with the 2020 Florida Building Code or standard industry practices. ***BE-CI recommends that wooden stair landings be repaired and that joist hangers be installed at all stairwells at all buildings within the next year by a licensed Florida contractor.*** (Reference Photo Exhibit Nos. 3 through 6)

Photo 4
Stairs – Between level 1 and 2 – Overall view of unstable boards.

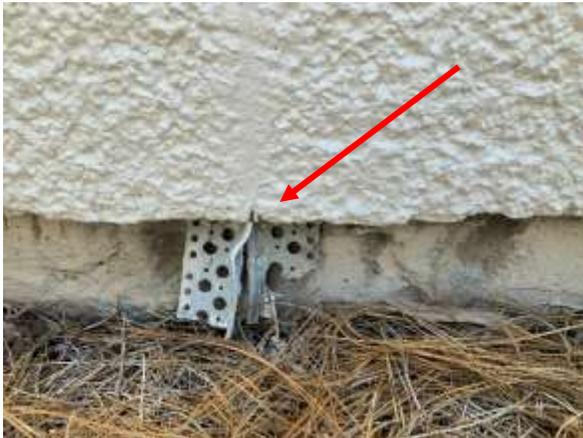
Photo 2
Base Of Wall – Ground level – Overall view of Stucco accessories at foundation.

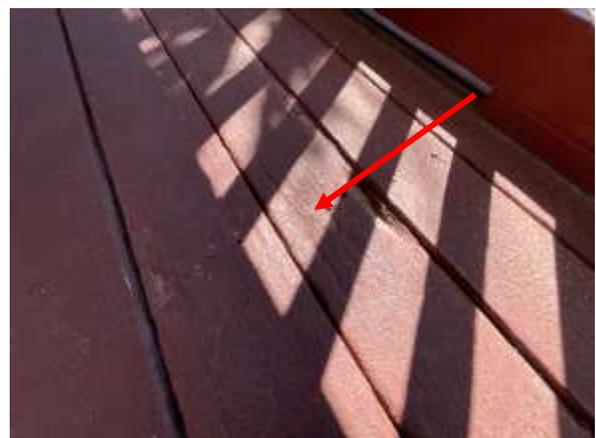
Photo 5
Stairs – Between level 1 and 2 – Overall view of unstable boards.

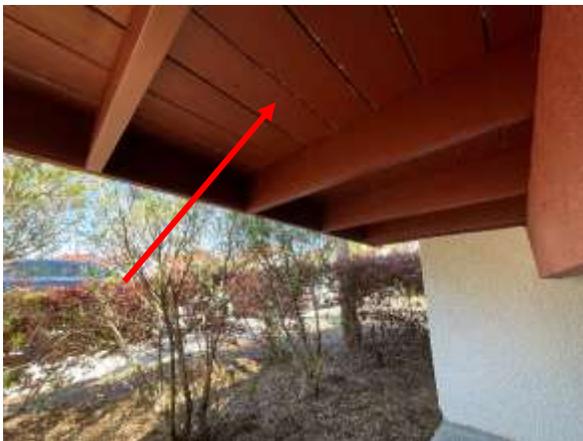
Photo 3
Stairs – Between level 1 and 2 – Overall view of unstable boards.

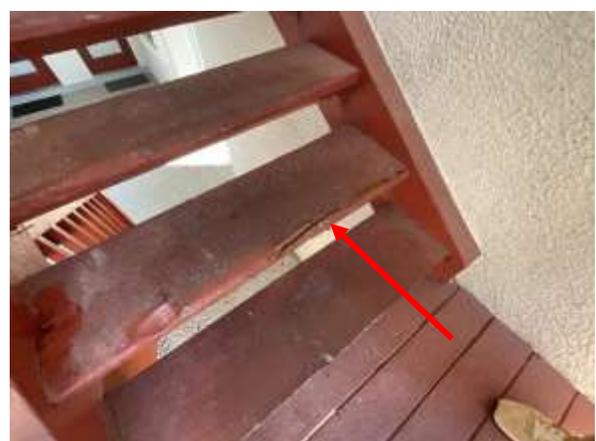
Photo 6
Stairs – Between level 1 and 2 – Overall view of unstable boards.

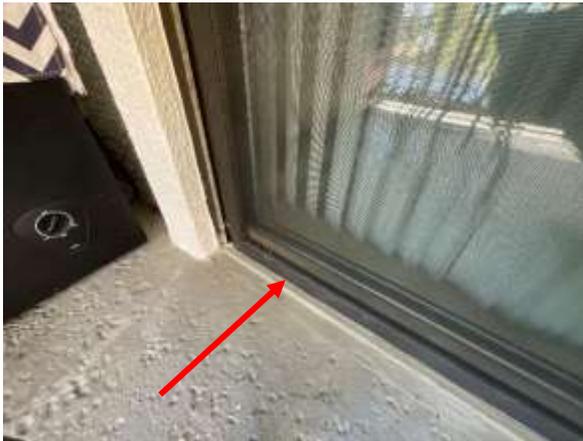
- 3.2.2 BE-CI also observed oxidation and finish failure to be widespread at the aluminum framed sliding glass doors at all buildings. BE-CI also observed abandoned fastener holes at door sills. ***BE-CI recommends that sliding glass doors be replaced or repaired by a licensed Florida contractor within the next 2-3 years as a part of the next exterior restoration project.*** (Reference Photo Exhibit Nos. 7 through 12)

Photo 7
 Private Balcony – 2nd Floor, – Overall view of base of sliding glass door.

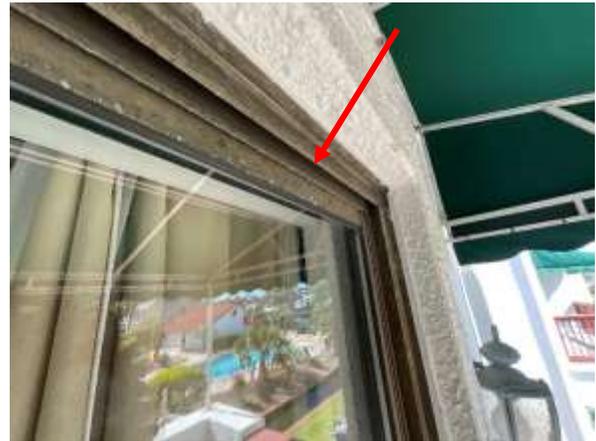
Photo 10
 Private Balcony – 2nd Floor, – Overall view of oxidation on top of sliding glass door frame.

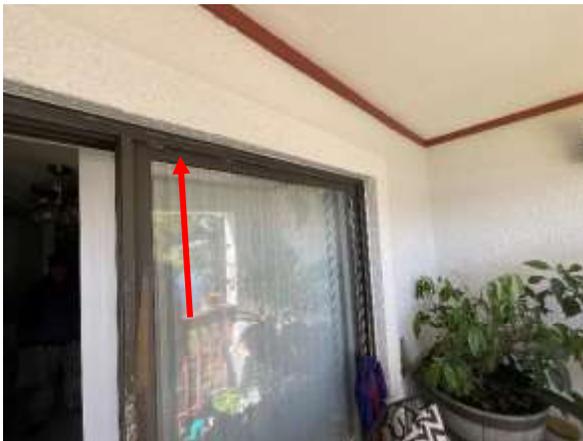
Photo 8
 Private Balcony – 2nd Floor, – Overall view of Oxidation on frame of sliding glass door.

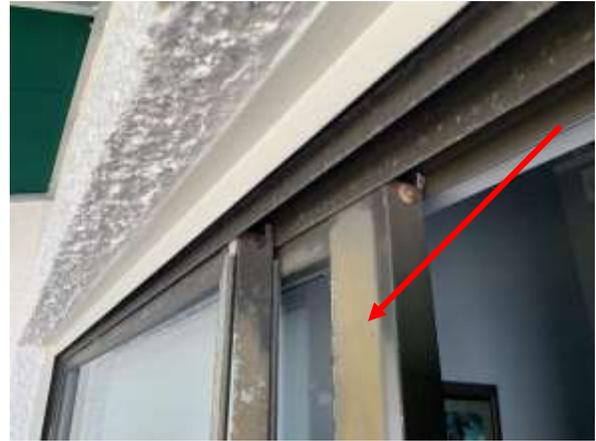
Photo 11
 Private Balcony – 2nd Floor, – Overall view of Oxidation on frame of sliding glass door.

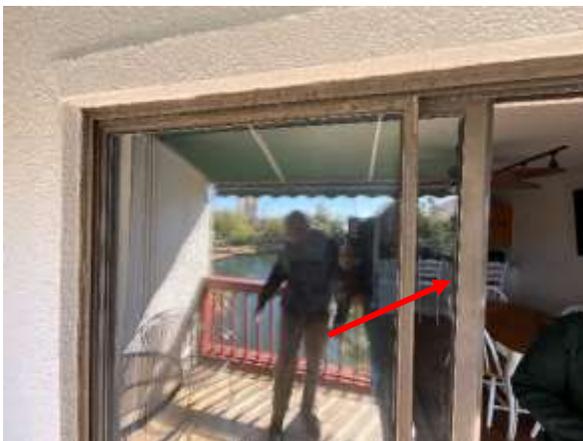
Photo 9
 Common Walkway – 2nd Floor, East End – Overall view of failed finish trim.

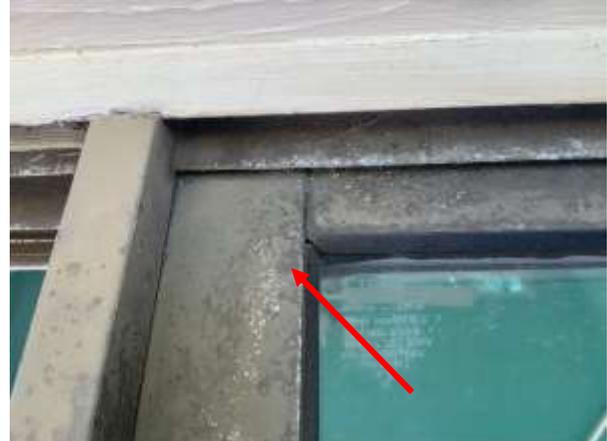
Photo 12
 Private Balcony – 2nd Floor, – Overall view of Oxidation on frame of sliding glass door.

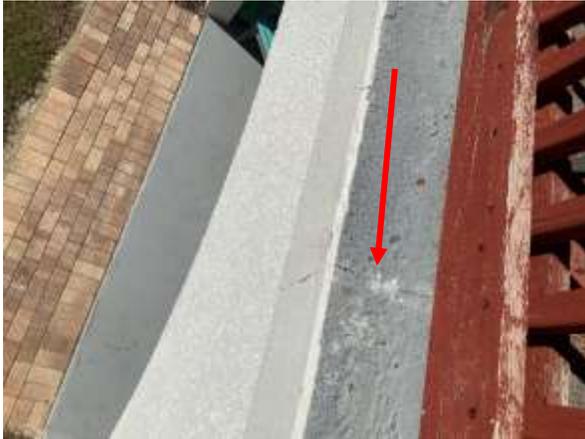
- 3.2.3 BE-CI observed isolated cracking and deck coating failure at slab edges on private balconies as well as common walkway areas at all buildings. ***BE-CI recommends that balcony slab edges be repaired and new deck coatings be installed within***

Photo 13
 Private Balcony – 2nd Floor, – Overall view of isolated cracks on balcony.

the next 2 years by a licensed Florida contractor. This will help prevent further concrete deterioration. (Reference Photo Exhibit Nos. 13 through 18 & 24 through 27)

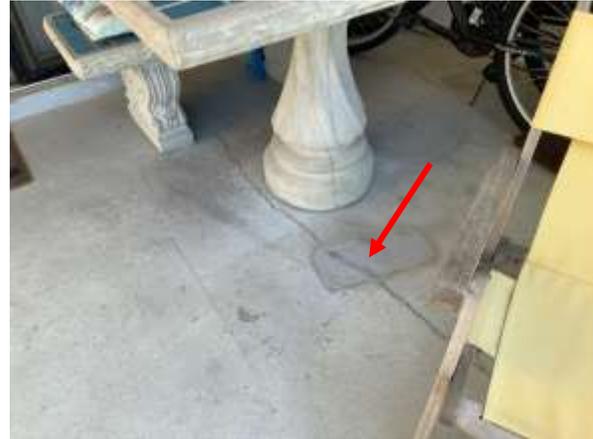
Photo 16
 Private Balcony – 2nd Floor, – Overall view of cracks on balcony.

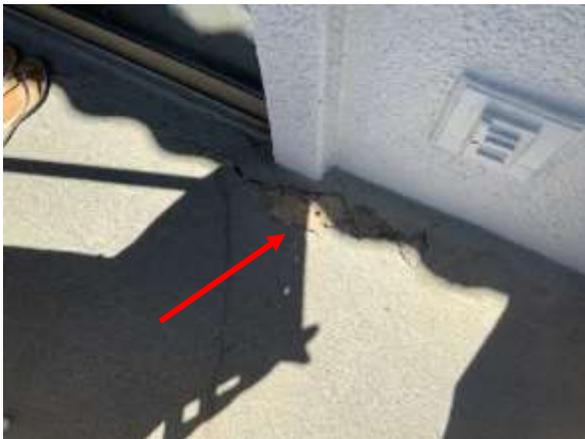
Photo 14
 Private Balcony – 2nd Floor, – Overall view of cracks and failed deck coating on balcony.

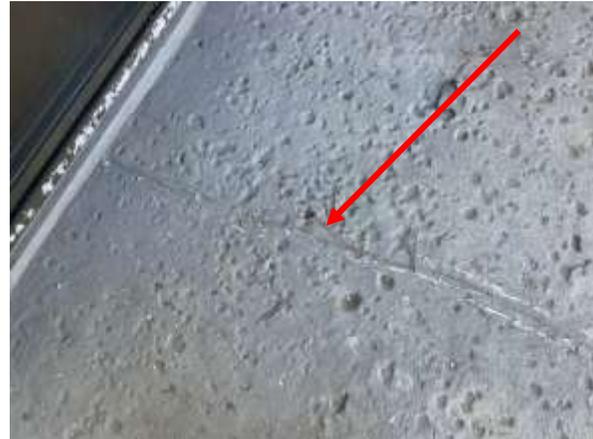
Photo 17
 Private Balcony – 2nd Floor, – Overall view of cracks on balcony.

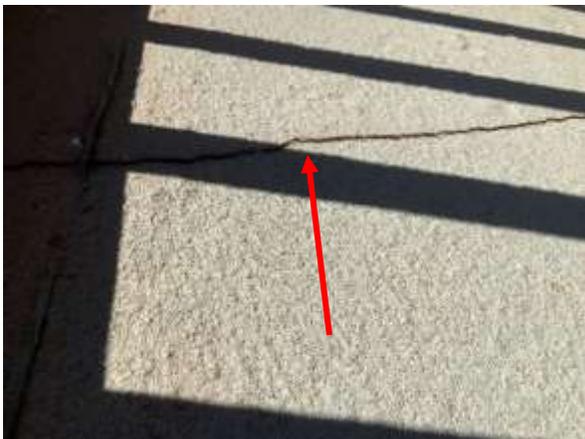
Photo 15
 Private Balcony – 2nd Floor, – Overall view of cracks and spalling on balcony.

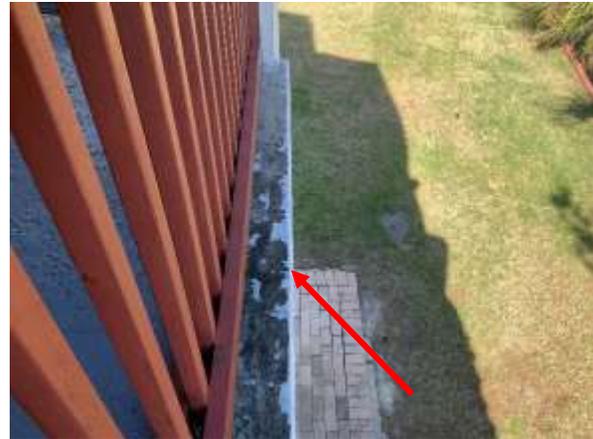
Photo 18
 Private Balcony – 2nd Floor, – Overall view of failed deck coating.

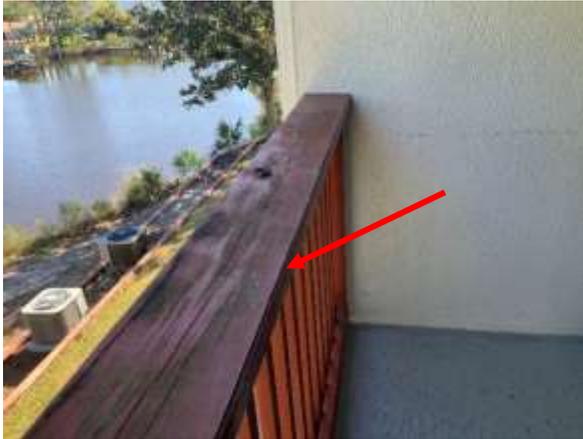
3.2.4 BE-CI also observed loose guardrails on private balconies. BE-CI also observed warped guardrails as a result of water damage. **BE-CI recommends that balcony guardrails be repaired within the next year by a licensed Florida contractor.** (Reference Photo Exhibit Nos. 19 through 23)

Photo 19
Private Balcony – 2nd Floor, – Overall view of cracked and oxidated guardrail.

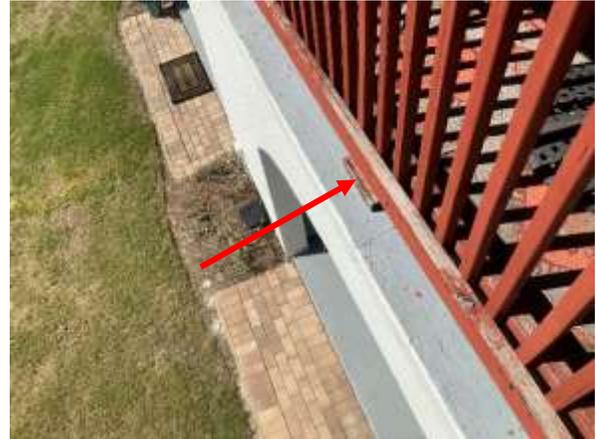
Photo 22
Private Balcony – 2nd Floor, – Overall view of balcony guardrail sagging.

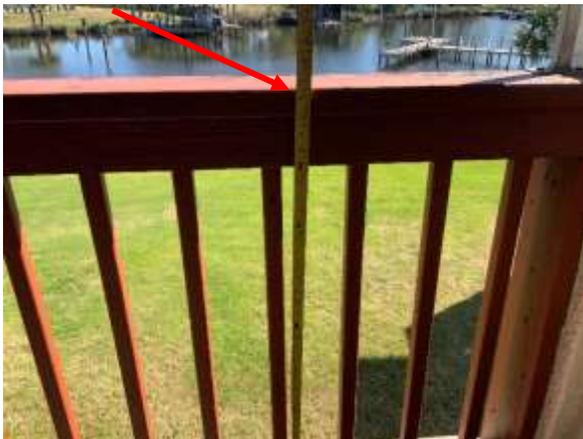
Photo 20
Private Balcony – 2nd Floor, – Overall view of balcony height below recommended 42 inches.

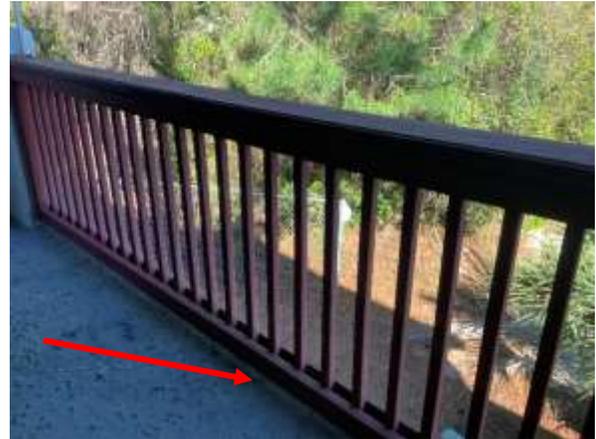
Photo 23
Private Balcony – 2nd Floor, – Overall view of balcony guardrail sagging.

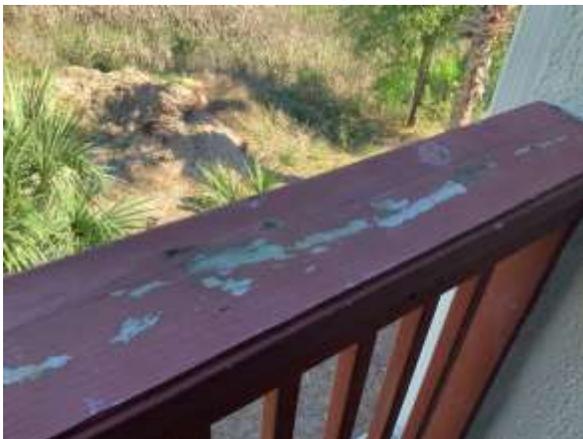
Photo 21
Private Balcony – 2nd Floor, – Overall view of cracked and oxidated guardrail.

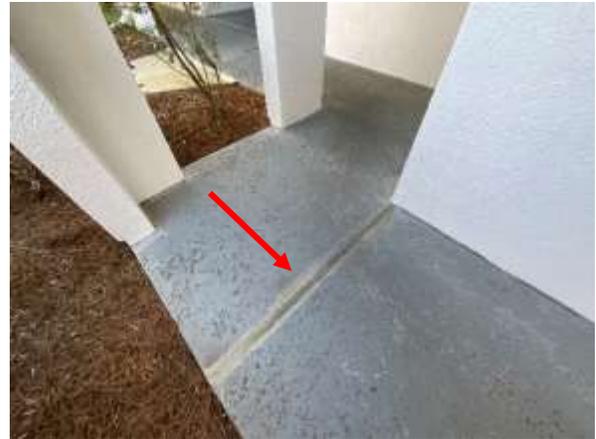
Photo 24
Common Walkway – 1st Floor, – Overall view of failed deck coating.

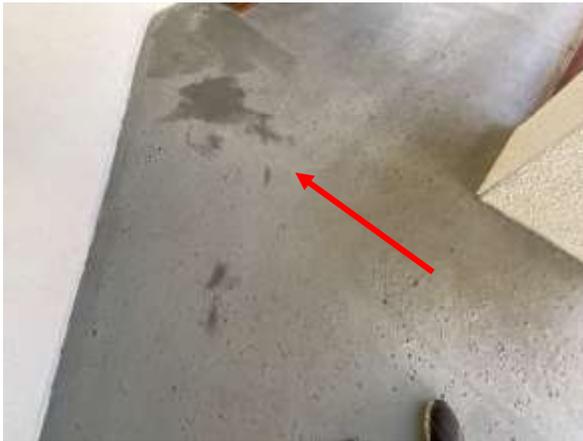
Photo 25
Common Walkway – 2nd Floor, – Overall view of failed deck coating.

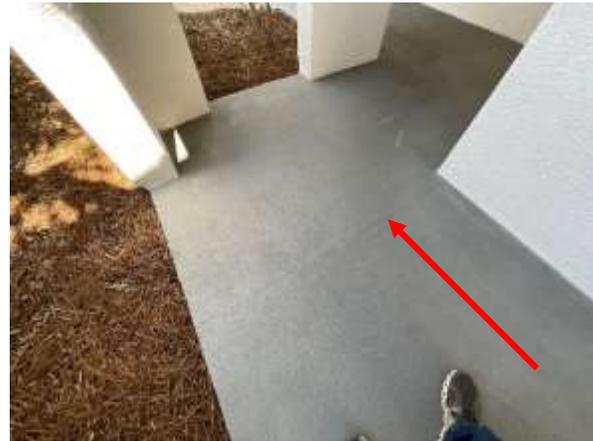
3.2.5 BE-CI observed isolated differential cracking at Building 5 on the common walkway. **BE-CI recommends that the differential cracking be repaired within the next year by a licensed Florida contractor.** (Reference Photo Exhibit Nos. 28 through 29)

Photo 28
Common Walkway – 1st Floor, – Overall view of cracked and spalled concrete.

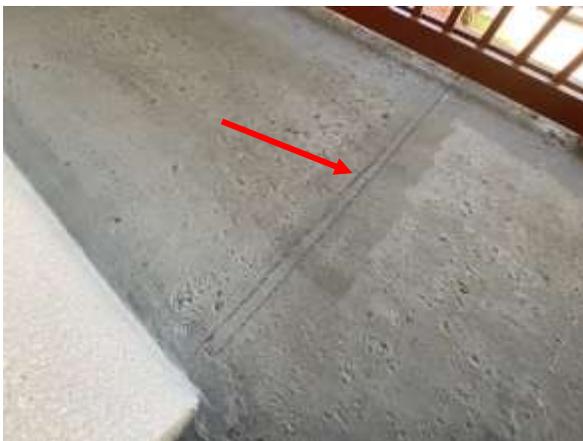
Photo 26
Common Walkway – 2nd Floor, – Overall view of cracked and spalled concrete.

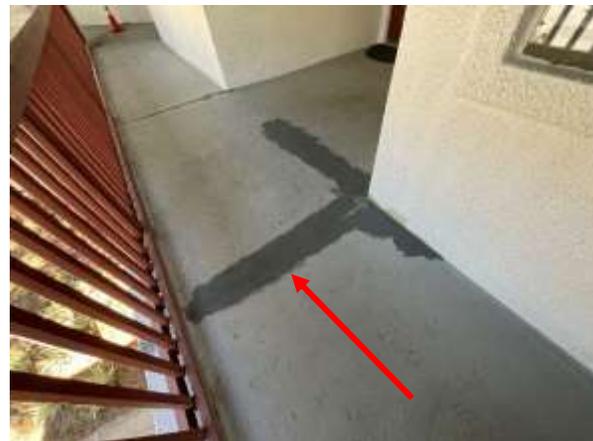
Photo 29
Common Walkway – 2nd Floor, – Overall view of cracked and spalled concrete.

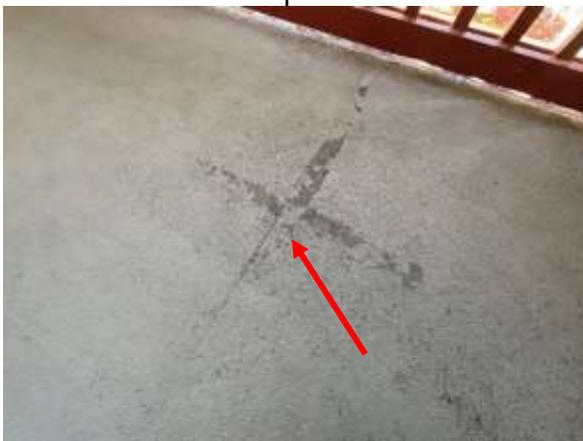
Photo 27
Common Walkway – 2nd Floor, – Overall view of failed deck coating.
