# Uniform Mitigation Verification Inspection Form

Inspection Date: 1/3/2022		
<b>Owner Information</b>		
Owner Name:		Contact Person:
Address: 8730 Thomas Dr. Building 5		Home Phone:
City: Panama City Beach	Zip: 32408	Work Phone:
County: Bay		Cell Phone:
Insurance Company:		Policy #:
Year of Home: 1984	# of Stories: 3	Email:

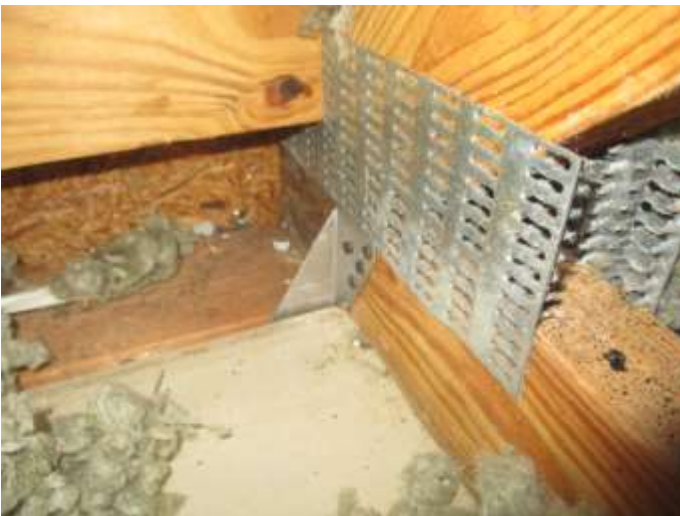
**Roof to Wall Connection:**

- ☒ Secured to truss/rafter with a minimum of three (3) nails, **and**
- ☒ Attached to the wall top plate of the wall framing, or embedded in the bond beam, with less than a 1/2" gap from the blocking or truss/rafter **and** blocked no more than 1.5" of the truss/rafter, **and** free of visible severe corrosion.

- ☒ B. Clips
  - ☒ Metal connectors that do not wrap over the top of the truss/rafter, **or**
  - ☐ Metal connectors with a minimum of 1 strap that wraps over the top of the truss/rafter and does not meet the nail position requirements of C or D, but is secured with a minimum of 3 nails.

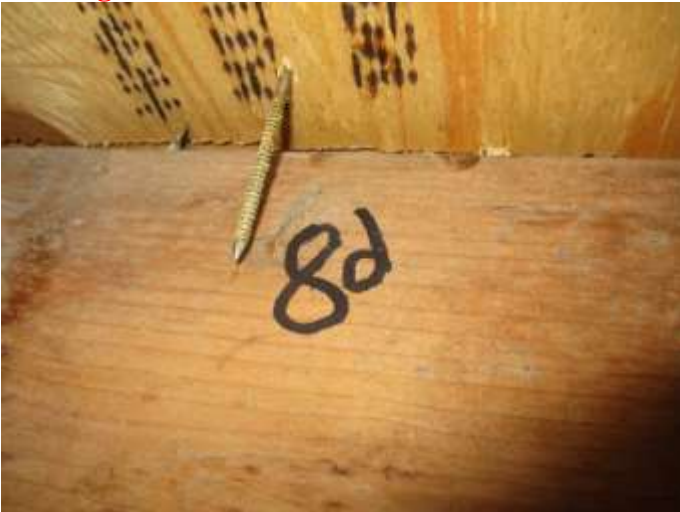
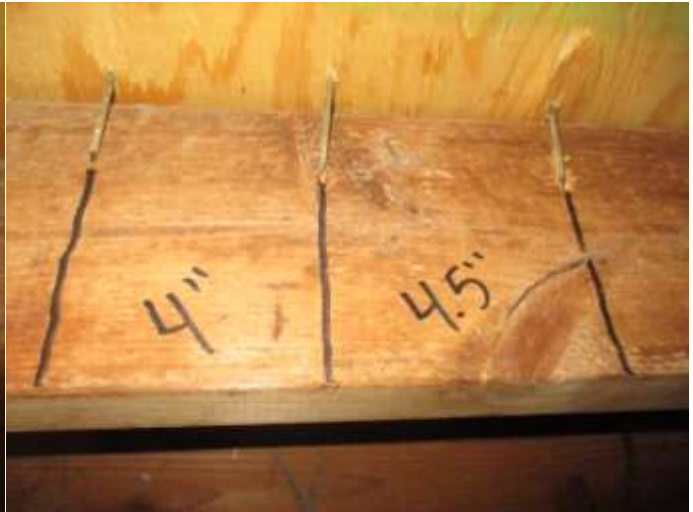
**Decking Connection:**

- ☒ C. Plywood/OSB roof sheathing with a minimum thickness of 7/16" inch attached to the roof truss/rafter (spaced a maximum of 24" inches o.c.) by 8d common nails spaced a maximum of 6" inches in the field. -OR- Dimensional lumber/Tongue & Groove decking with a minimum of 2 nails per board (or 1 nail per board if each board is equal to or less than 6 inches in width). -OR-

Any system of screws, nails, adhesives, other deck fastening system or truss/rafter spacing that is shown to have an equivalent or greater resistance than 8d common nails spaced a maximum of 6 inches in the field or has a mean uplift resistance of at least 182 psf.
