Uniform Mitigation Verification Inspection Form

Inspection Date: Wednesday, January 22, 2020		
Owner Information		
Owner Name:		Contact Person:
Address: 8730 Thomas Dr.		Home Phone:
City: Panama City	Zip: 32408	Work Phone:
County: Bay		Cell Phone:
Insurance Company:		Policy #:
Year of Home: 1985	# of Stories: 3	Email:

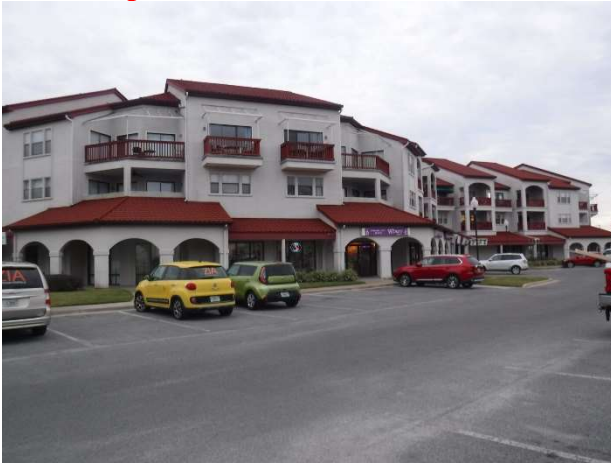
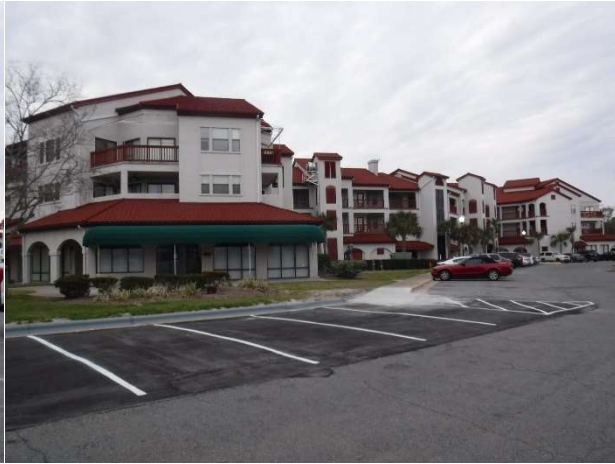
Roof Shape:

- ☐ A. Hip Roof Hip roof with no other roof shapes greater than 10% of the total roof system perimeter.
Total length of non-hip features: _____ feet; Total roof system perimeter: _____ feet
- ☐ B. Flat Roof Roof on a building with 5 or more units where at least 90% of the main roof area has a roof slope of less than 2:12. Roof area with slope less than 2:12 _____ sq ft; Total roof area _____ sq ft
- ☒ C. Other Roof Any roof that does not qualify as either (A) or (B) above.

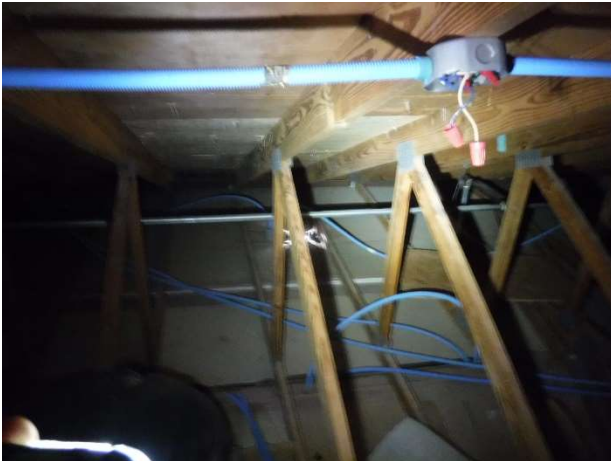
Roof to Wall Connection:

- ☒ Secured to truss/rafter with a minimum of three (3) nails, **and**
- ☒ Attached to the wall top plate of the wall framing, or embedded in the bond beam, with less than a 1/2" gap from the blocking or truss/rafter **and** blocked no more than 1.5" of the truss/rafter, **and** free of visible severe corrosion.

- ☒ B. Clips
 - ☒ Metal connectors that do not wrap over the top of the truss/rafter, **or**
 - ☐ Metal connectors with a minimum of 1 strap that wraps over the top of the truss/rafter and does not meet the nail position requirements of C or D, but is secured with a minimum of 3 nails.

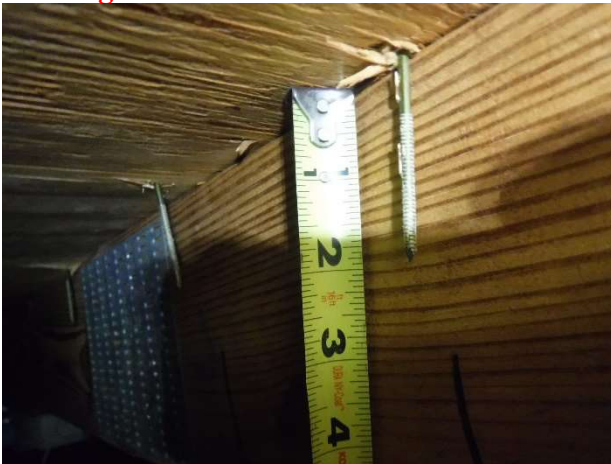
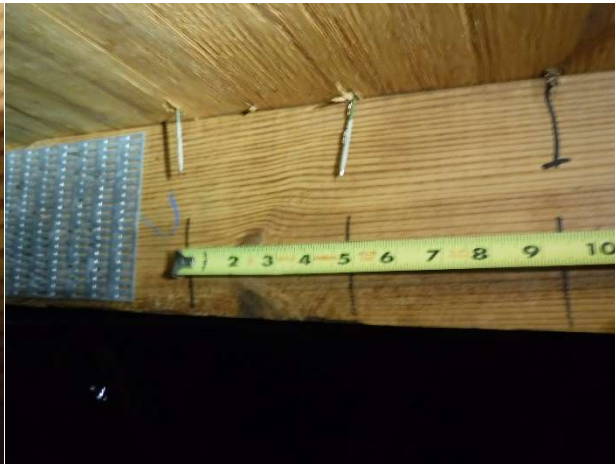
Decking Connection:

- ☒ C. Plywood/OSB roof sheathing with a minimum thickness of 7/16" inch attached to the roof truss/rafter (spaced a maximum of 24" inches o.c.) by 8d common nails spaced a maximum of 6" inches in the field. -OR- Dimensional lumber/Tongue & Groove decking with a minimum of 2 nails per board (or 1 nail per board if each board is equal to or less than 6 inches in width). -OR- Any system of screws, nails, adhesives, other deck fastening system or truss/rafter spacing that is shown to have an equivalent or

greater resistance than 8d common nails spaced a maximum of 6 inches in the field or has a mean uplift resistance of at least 182 psf.
