Uniform Mitigation Verification Inspection Form

Inspection Date: 1/3/2022		
Owner Information		
Owner Name:		Contact Person:
Address: 8730 Thomas Dr. Building 2		Home Phone:
City: Panama City Beach	Zip: 32408	Work Phone:
County: Bay		Cell Phone:
Insurance Company:		Policy #:
Year of Home: 1984	# of Stories: 3	Email:

Inspectors Initials CS Property Address: 8730 Thomas Dr. Building 2, Panama City Beach, FL 32408

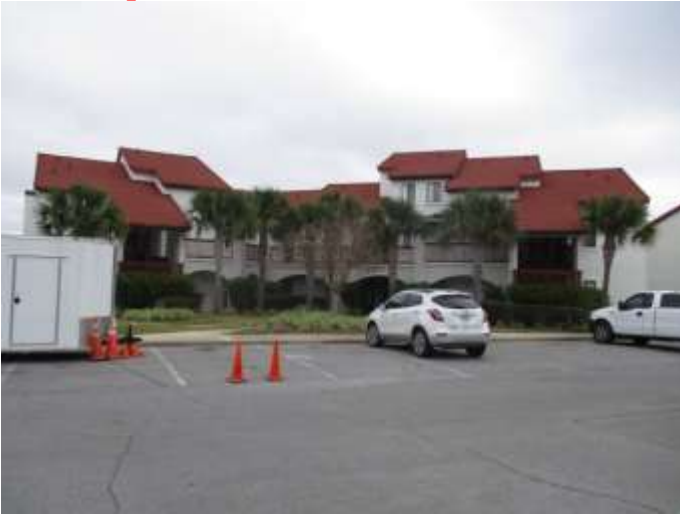
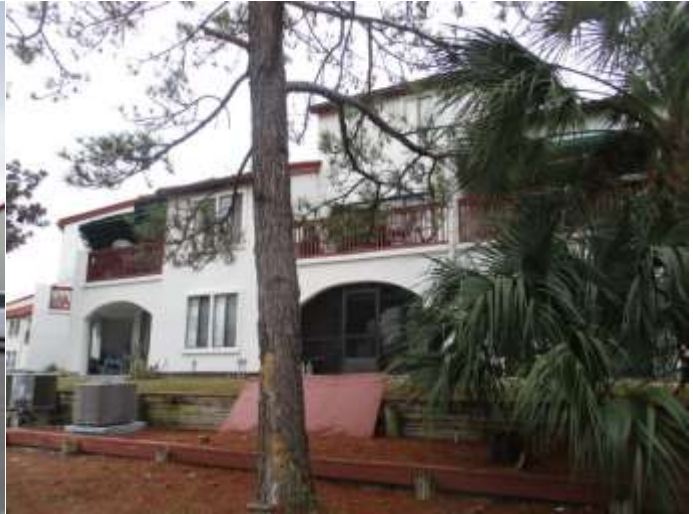
Roof Shape:

- ☐ A. Hip Roof Hip roof with no other roof shapes greater than 10% of the total roof system perimeter.
Total length of non-hip features: _____ feet; Total roof system perimeter: _____ feet
- ☐ B. Flat Roof Roof on a building with 5 or more units where at least 90% of the main roof area has a roof slope of less than 2:12. Roof area with slope less than 2:12 _____ sq ft; Total roof area _____ sq ft
- ☒ C. Other Roof Any roof that does not qualify as either (A) or (B) above.

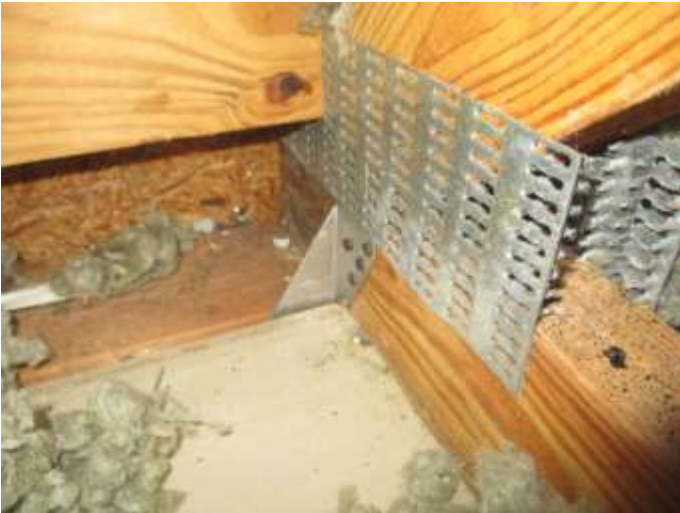
Roof to Wall Connection:

- ☒ Secured to truss/rafter with a minimum of three (3) nails, **and**
- ☒ Attached to the wall top plate of the wall framing, or embedded in the bond beam, with less than a 1/2" gap from the blocking or truss/rafter **and** blocked no more than 1.5" of the truss/rafter, **and** free of visible severe corrosion.

- ☒ B. Clips
 - ☒ Metal connectors that do not wrap over the top of the truss/rafter, **or**
 - ☐ Metal connectors with a minimum of 1 strap that wraps over the top of the truss/rafter and does not meet the nail position requirements of C or D, but is secured with a minimum of 3 nails.

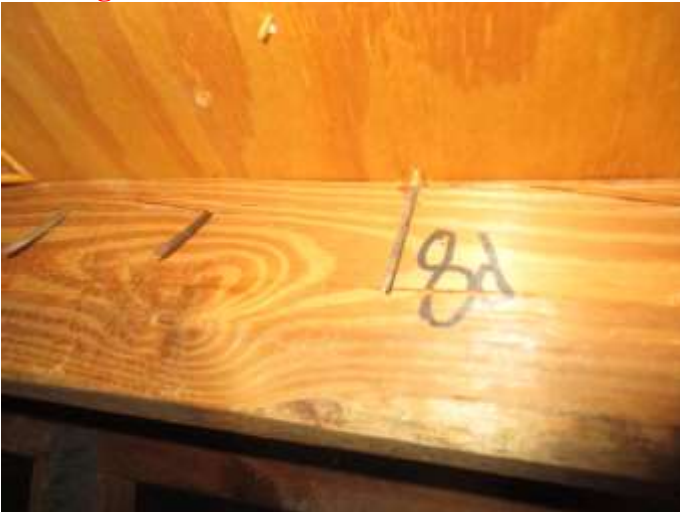
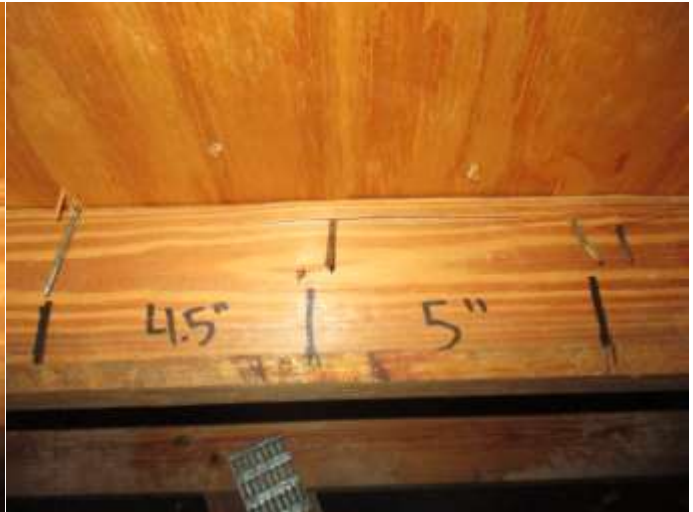
Decking Connection:

- ☒ C. Plywood/OSB roof sheathing with a minimum thickness of 7/16" inch attached to the roof truss/rafter (spaced a maximum of 24" inches o.c.) by 8d common nails spaced a maximum of 6" inches in the field. -OR- Dimensional lumber/Tongue & Groove decking with a minimum of 2 nails per board (or 1 nail per board if each board is equal to or less than 6 inches in width). -OR-

Any system of screws, nails, adhesives, other deck fastening system or truss/rafter spacing that is shown to have an equivalent or greater resistance than 8d common nails spaced a maximum of 6 inches in the field or has a mean uplift resistance of at least 182 psf.
