Uniform Mitigation Verification Inspection Form

Inspection Date: 1/3/2022		
Owner Information		
Owner Name:		Contact Person:
Address: 8730 Thomas Dr. Building 4		Home Phone:
City: Panama City Beach	Zip: 32408	Work Phone:
County: Bay		Cell Phone:
Insurance Company:		Policy #:
Year of Home: 1984	# of Stories: 3	Email:

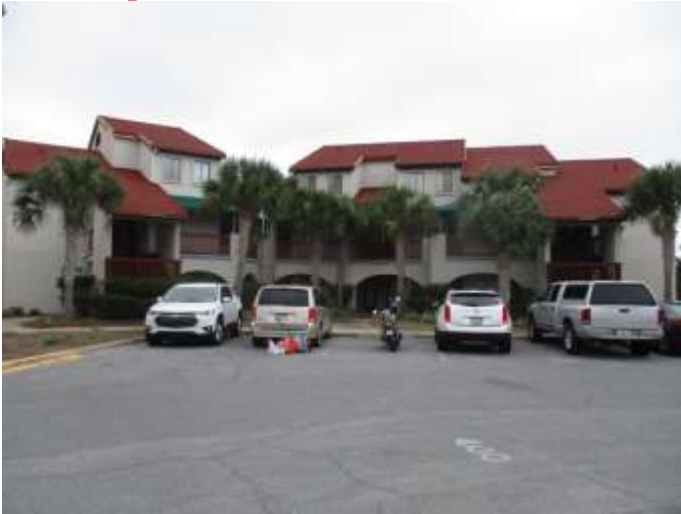
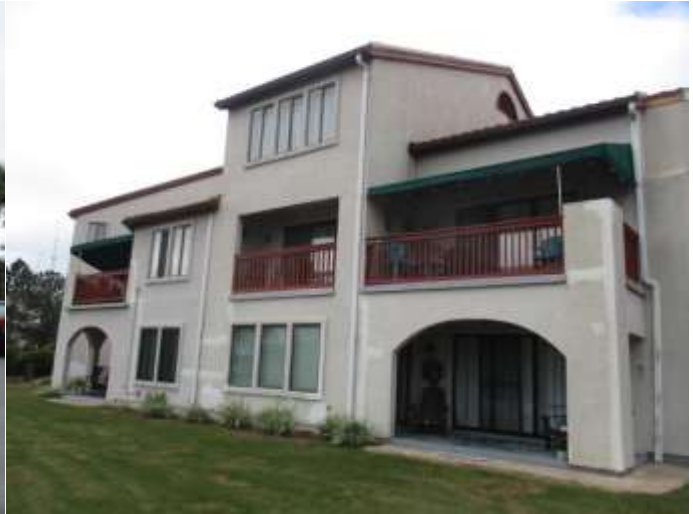
Roof Shape:

- ☐ A. Hip Roof Hip roof with no other roof shapes greater than 10% of the total roof system perimeter.
Total length of non-hip features: _____ feet; Total roof system perimeter: _____ feet
- ☐ B. Flat Roof Roof on a building with 5 or more units where at least 90% of the main roof area has a roof slope of less than 2:12. Roof area with slope less than 2:12 _____ sq ft; Total roof area _____ sq ft
- ☒ C. Other Roof Any roof that does not qualify as either (A) or (B) above.

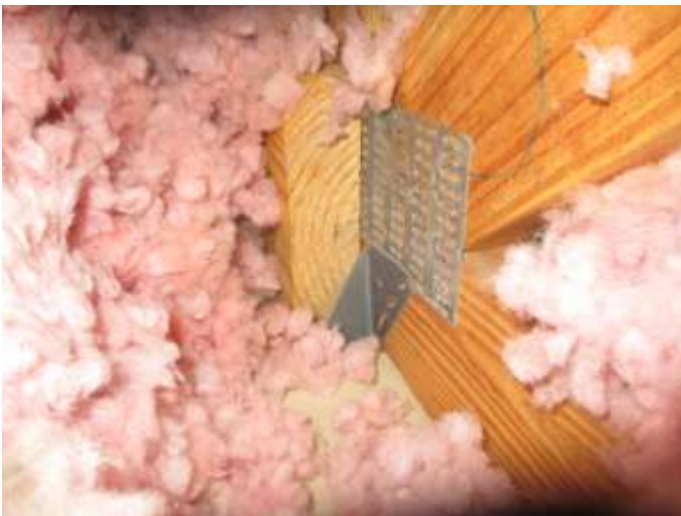
Roof to Wall Connection:

- ☒ Secured to truss/rafter with a minimum of three (3) nails, **and**
- ☒ Attached to the wall top plate of the wall framing, or embedded in the bond beam, with less than a 1/2" gap from the blocking or truss/rafter **and** blocked no more than 1.5" of the truss/rafter, **and** free of visible severe corrosion.

- ☒ B. Clips
 - ☒ Metal connectors that do not wrap over the top of the truss/rafter, **or**
 - ☐ Metal connectors with a minimum of 1 strap that wraps over the top of the truss/rafter and does not meet the nail position requirements of C or D, but is secured with a minimum of 3 nails.

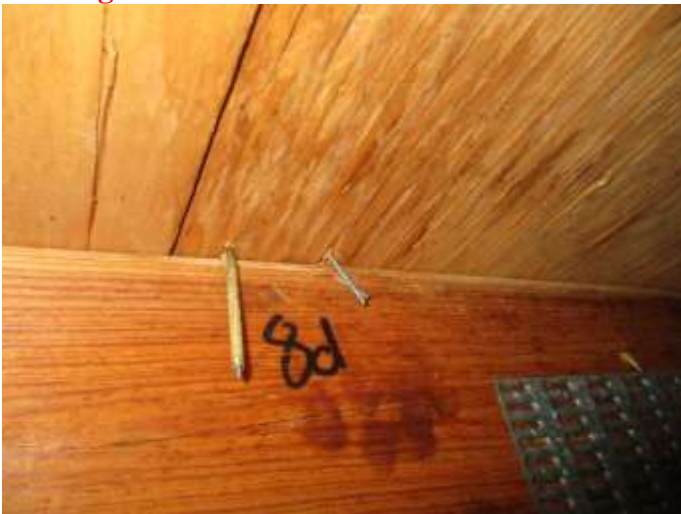
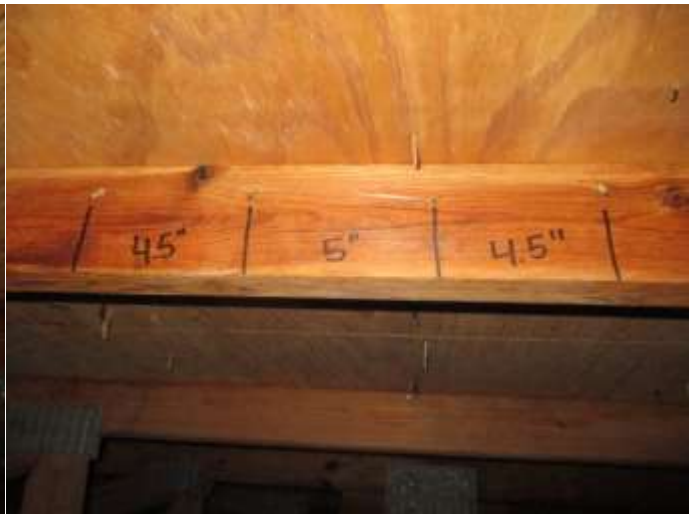
Decking Connection:

- ☒ C. Plywood/OSB roof sheathing with a minimum thickness of 7/16" inch attached to the roof truss/rafter (spaced a maximum of 24" inches o.c.) by 8d common nails spaced a maximum of 6" inches in the field. -OR- Dimensional lumber/Tongue & Groove decking with a minimum of 2 nails per board (or 1 nail per board if each board is equal to or less than 6 inches in width). -OR-

Any system of screws, nails, adhesives, other deck fastening system or truss/rafter spacing that is shown to have an equivalent or greater resistance than 8d common nails spaced a maximum of 6 inches in the field or has a mean uplift resistance of at least 182 psf.
