# Uniform Mitigation Verification Inspection Form

Inspection Date: 1/3/2022		
<b>Owner Information</b>		
Owner Name:		Contact Person:
Address: 8730 Thomas Dr. Building 3		Home Phone:
City: Panama City Beach	Zip: 32408	Work Phone:
County: Bay		Cell Phone:
Insurance Company:		Policy #:
Year of Home: 1984	# of Stories: 3	Email:

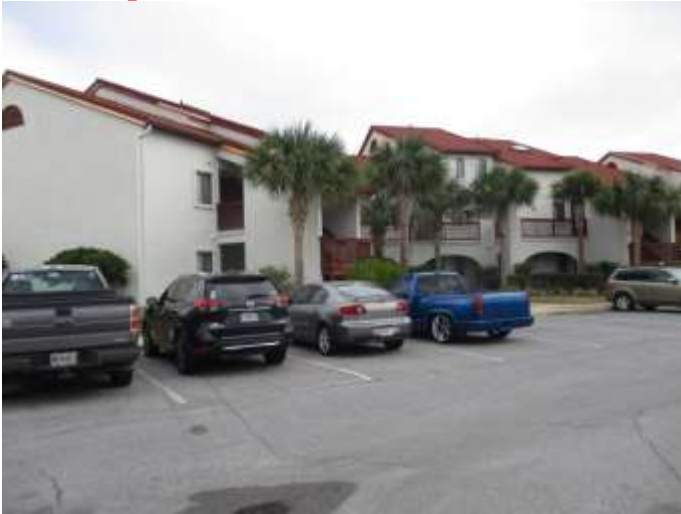
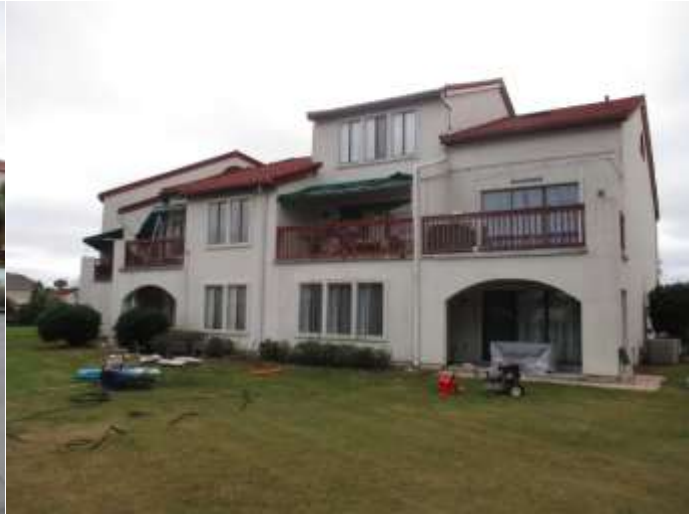
**Roof Shape:**

- ☐ A. Hip Roof Hip roof with no other roof shapes greater than 10% of the total roof system perimeter.  
Total length of non-hip features: \_\_\_\_\_ feet; Total roof system perimeter: \_\_\_\_\_ feet
- ☐ B. Flat Roof Roof on a building with 5 or more units where at least 90% of the main roof area has a roof slope of less than 2:12. Roof area with slope less than 2:12 \_\_\_\_\_ sq ft; Total roof area \_\_\_\_\_ sq ft
- ☒ C. Other Roof Any roof that does not qualify as either (A) or (B) above.

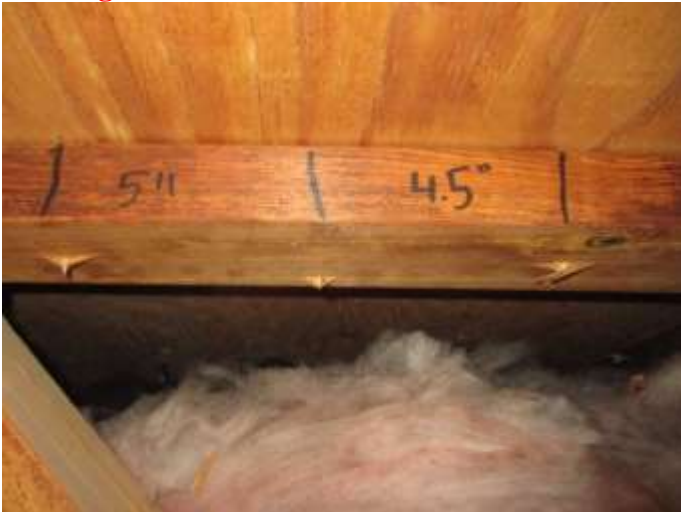
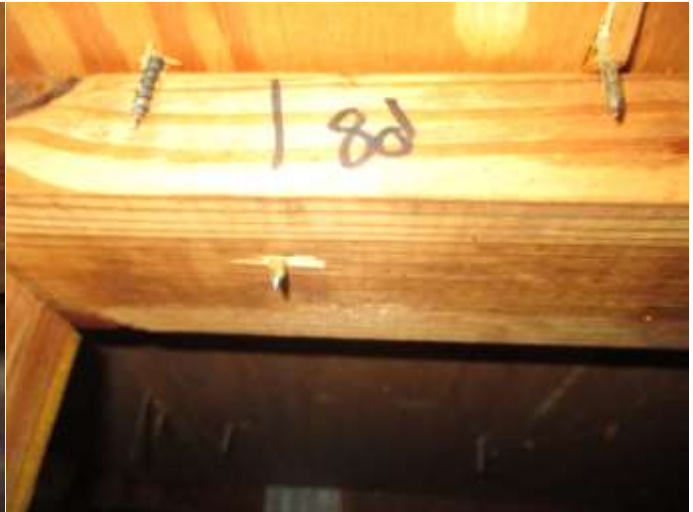
**Decking Connection:**

- ☒ C. Plywood/OSB roof sheathing with a minimum thickness of 7/16" inch attached to the roof truss/rafter (spaced a maximum of 24" inches o.c.) by 8d common nails spaced a maximum of 6" inches in the field. -OR- Dimensional lumber/Tongue & Groove decking with a minimum of 2 nails per board (or 1 nail per board if each board is equal to or less than 6 inches in width). -OR-

Any system of screws, nails, adhesives, other deck fastening system or truss/rafter spacing that is shown to have an equivalent or greater resistance than 8d common nails spaced a maximum of 6 inches in the field or has a mean uplift resistance of at least 182 psf.
