Uniform Mitigation Verification Inspection Form

Inspection Date: 1/3/2022		
Owner Information		
Owner Name:		Contact Person:
Address: 8730 Thomas Dr. Building 1		Home Phone:
City: Panama City Beach	Zip: 32408	Work Phone:
County: Bay		Cell Phone:
Insurance Company:		Policy #:
Year of Home: 1984	# of Stories: 3	Email:

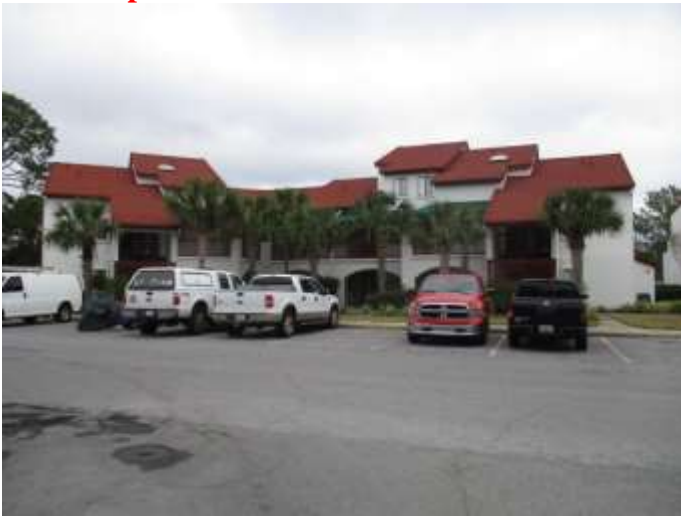
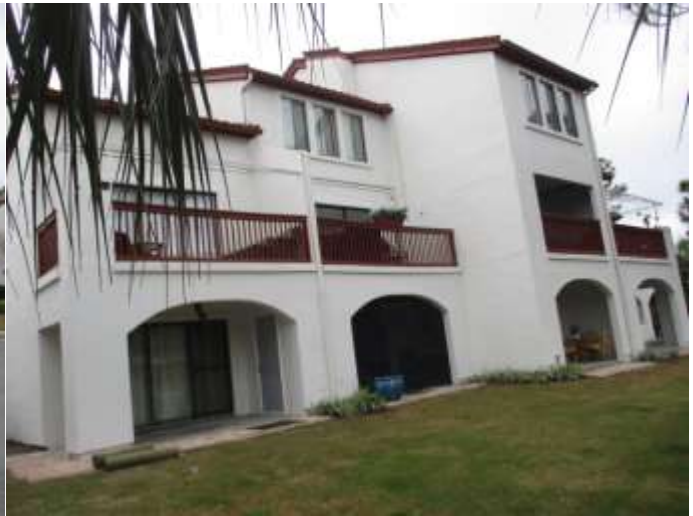
Roof Shape:

5. **Roof Geometry:** What is the roof shape? (Do not consider roofs of porches or carports that are attached only to the fascia or wall of the host structure over unenclosed space in the determination of roof perimeter or roof area for roof geometry classification).

- ☐ A. Hip Roof Hip roof with no other roof shapes greater than 10% of the total roof system perimeter.
Total length of non-hip features: _____ feet; Total roof system perimeter: _____ feet
- ☐ B. Flat Roof Roof on a building with 5 or more units where at least 90% of the main roof area has a roof slope of less than 2:12. Roof area with slope less than 2:12 _____ sq ft; Total roof area _____ sq ft
- ☒ C. Other Roof Any roof that does not qualify as either (A) or (B) above.

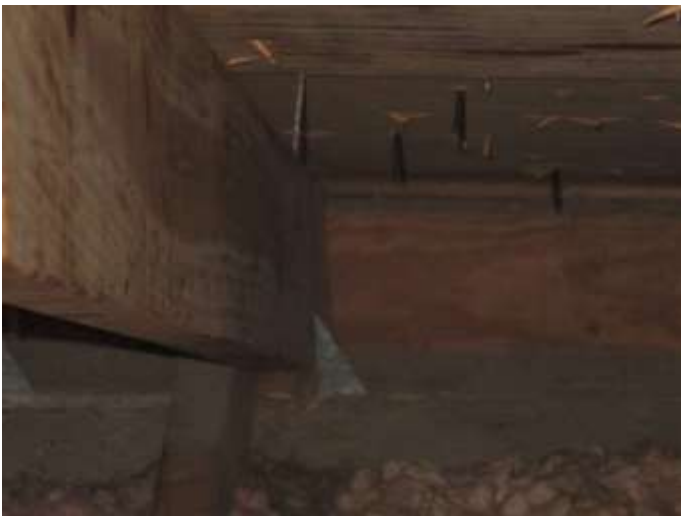
Roof to Wall Connection:

4. **Roof to Wall Attachment:** What is the **WEAKEST** roof to wall connection? (Do not include attachment of hip/valley jacks within 5 feet of the inside or outside corner of the roof in determination of WEAKEST type)

- ☒ Secured to truss/rafter with a minimum of three (3) nails, **and**
- ☒ Attached to the wall top plate of the wall framing, or embedded in the bond beam, with less than a 1/2" gap from the blocking or truss/rafter **and** blocked no more than 1.5" of the truss/rafter, **and** free of visible severe corrosion.

- ☒ B. Clips
 - ☒ Metal connectors that do not wrap over the top of the truss/rafter, **or**
 - ☐ Metal connectors with a minimum of 1 strap that wraps over the top of the truss/rafter and does not meet the nail position requirements of C or D, but is secured with a minimum of 3 nails.

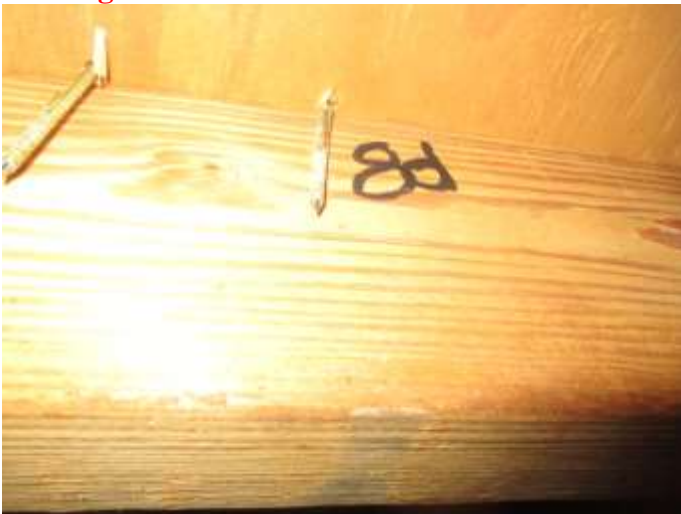
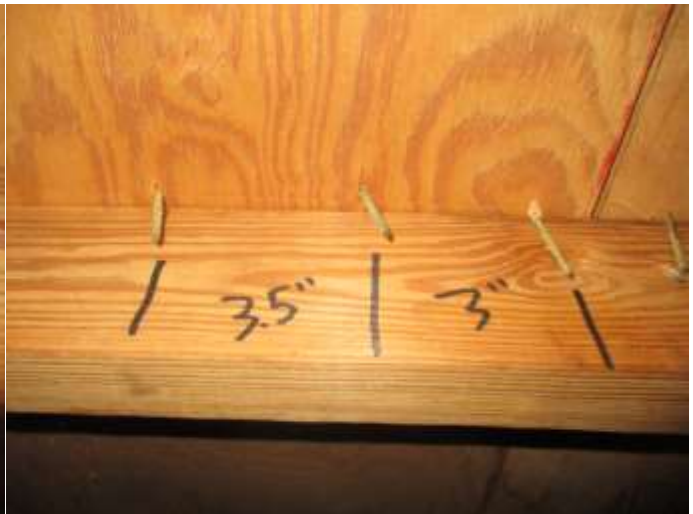
Decking Connection:

3. **Roof Deck Attachment:** What is the **weakest** form of roof deck attachment?
- ☐ A. Plywood/Oriented strand board (OSB) roof sheathing attached to the roof truss/rafter (spaced a maximum of 24" inches o.c.) by staples or 6d nails spaced at 6" along the edge and 12" in the field. -OR- Batten decking supporting wood shakes or wood shingles. -OR- Any system of screws, nails, adhesives, other deck fastening system or truss/rafter spacing that has an equivalent mean uplift less than that required for Options B or C below.

- ☒ C. Plywood/OSB roof sheathing with a minimum thickness of 7/16" inch attached to the roof truss/rafter (spaced a maximum of 24" inches o.c.) by 8d common nails spaced a maximum of 6" inches in the field. -OR- Dimensional lumber/Tongue & Groove decking with a minimum of 2 nails per board (or 1 nail per board if each board is equal to or less than 6 inches in width). -OR-

Any system of screws, nails, adhesives, other deck fastening system or truss/rafter spacing that is shown to have an equivalent or greater resistance than 8d common nails spaced a maximum of 6 inches in the field or has a mean uplift resistance of at least 182 psf.
